# City Hall Park

Great Streets BTV

City Hall Park Landscape Plan – March 7, 2018

# 2018 City Hall Park Landscape Design – February 20<sup>th</sup> DRB

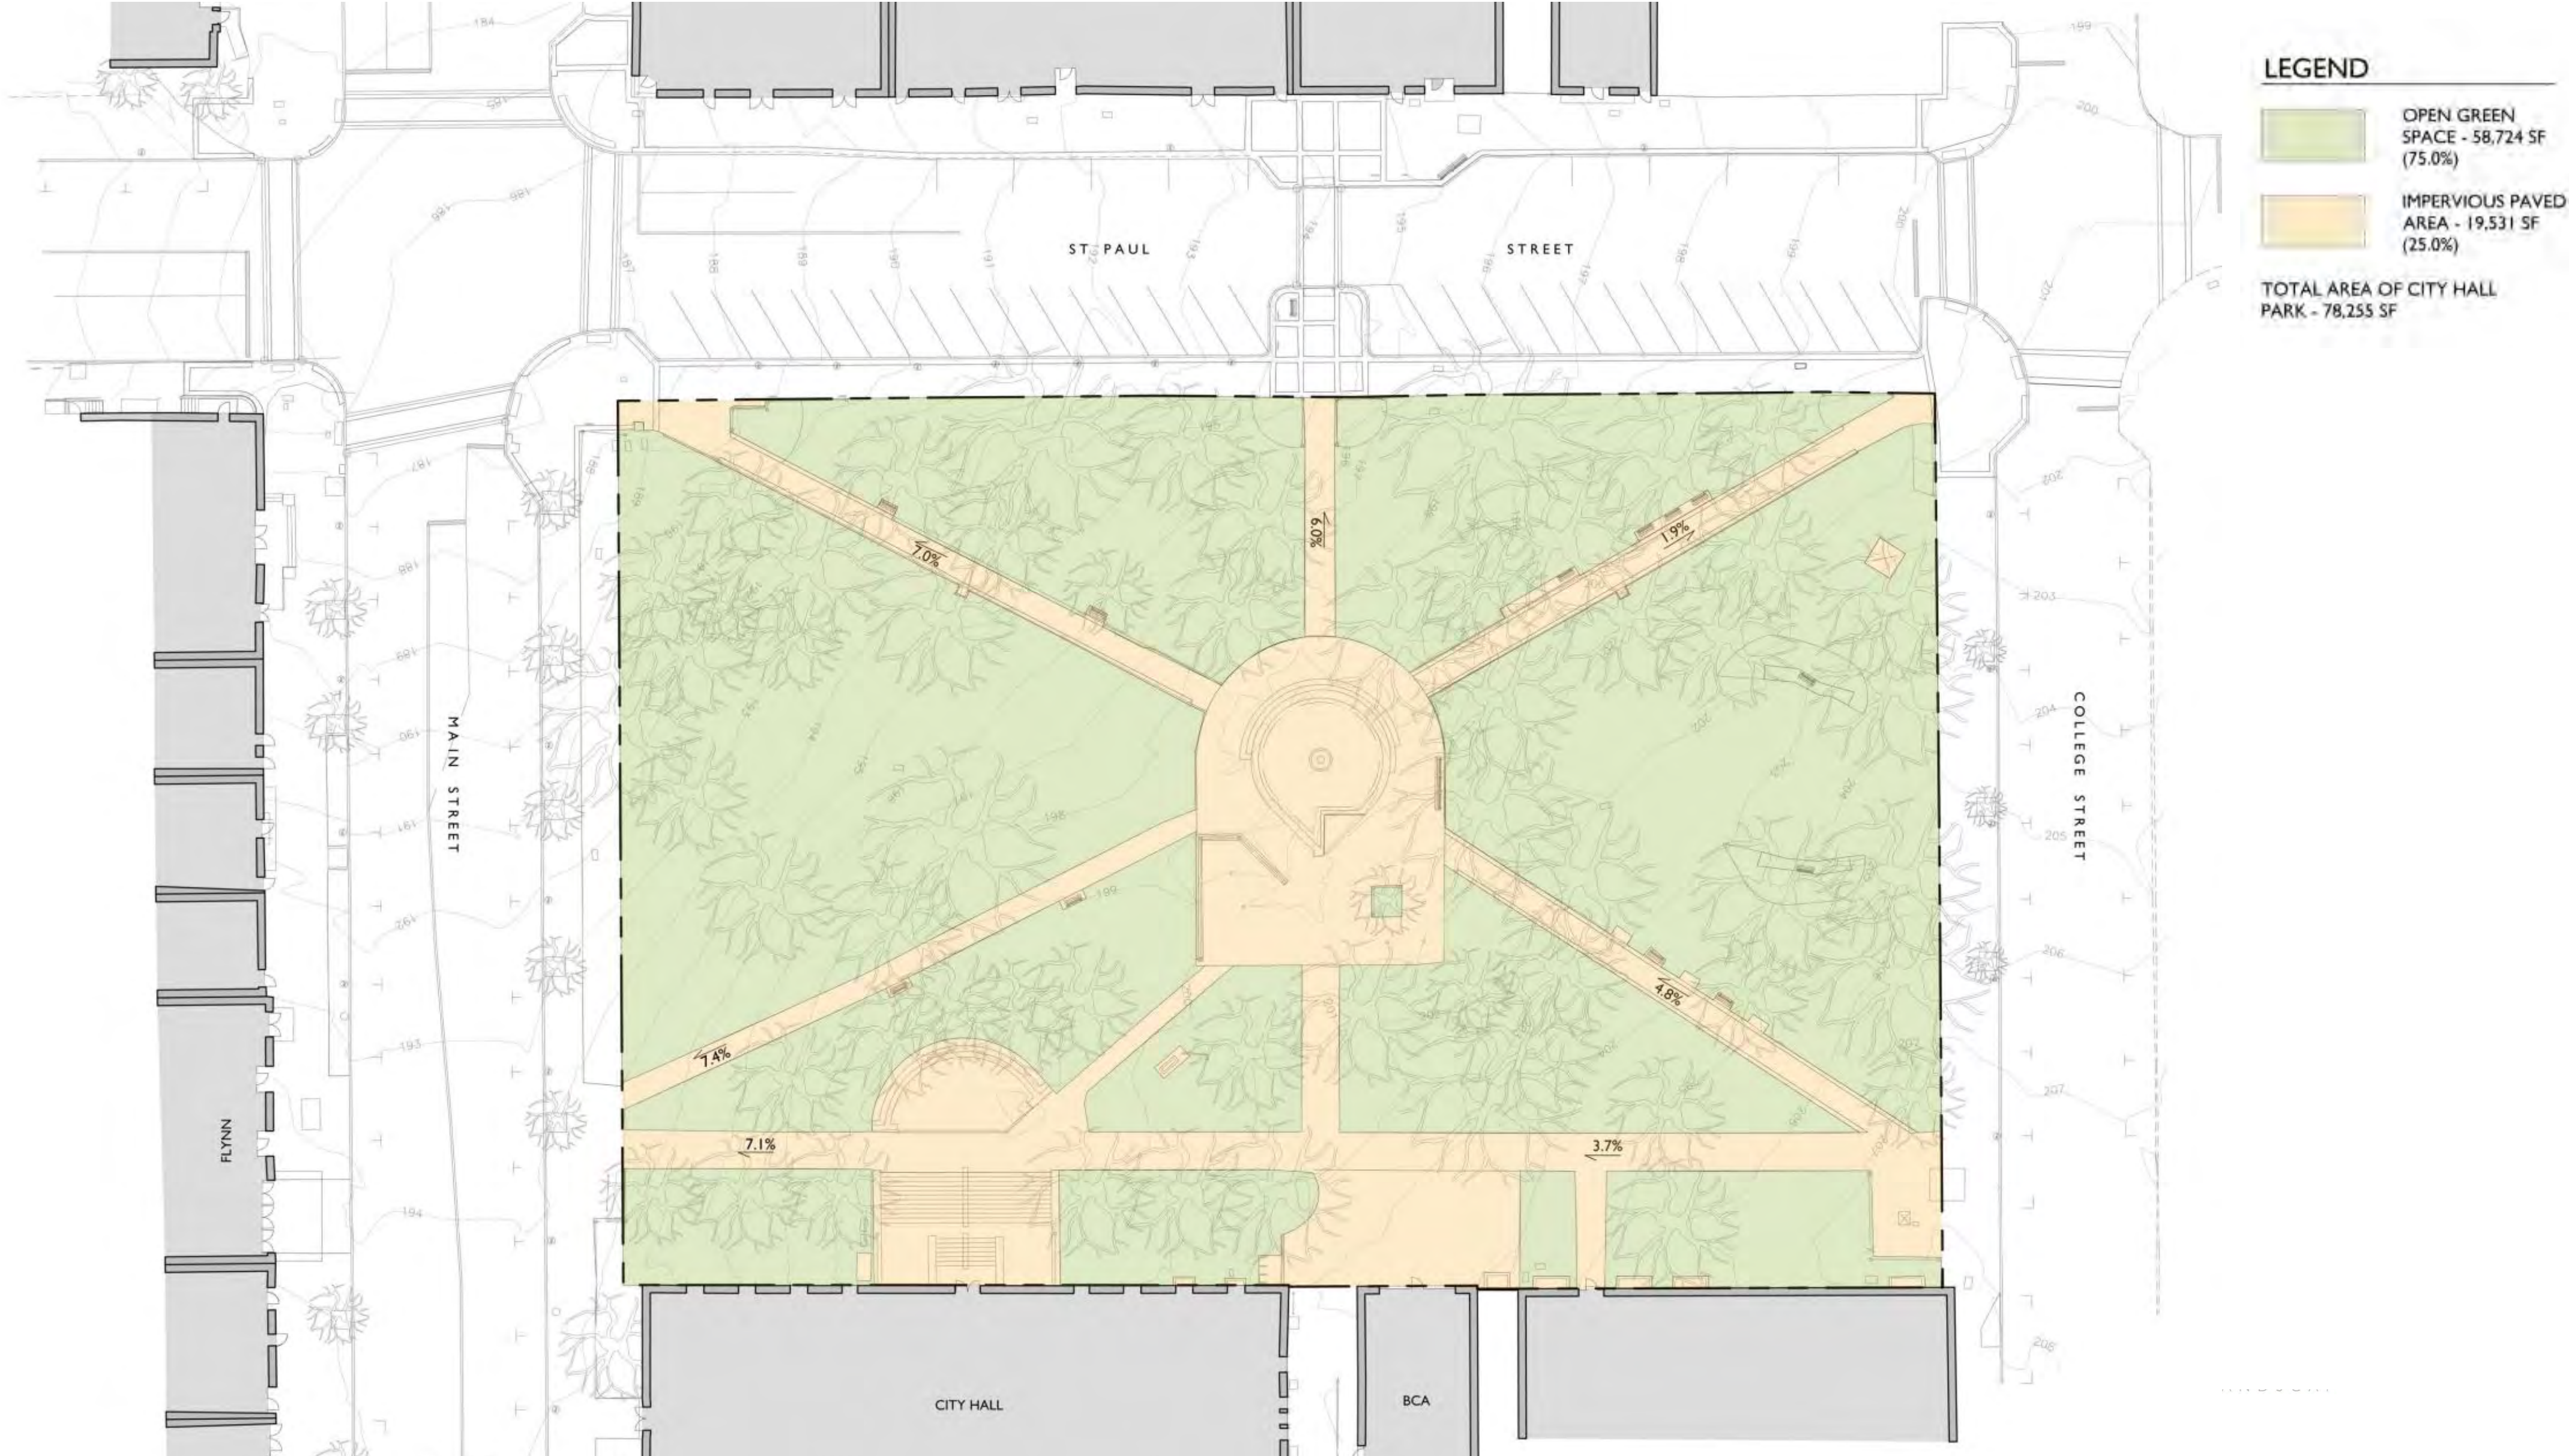
Existing Site Plan

2016 Site Analysis  
Green Open Space & Impervious Surfaces Comparison

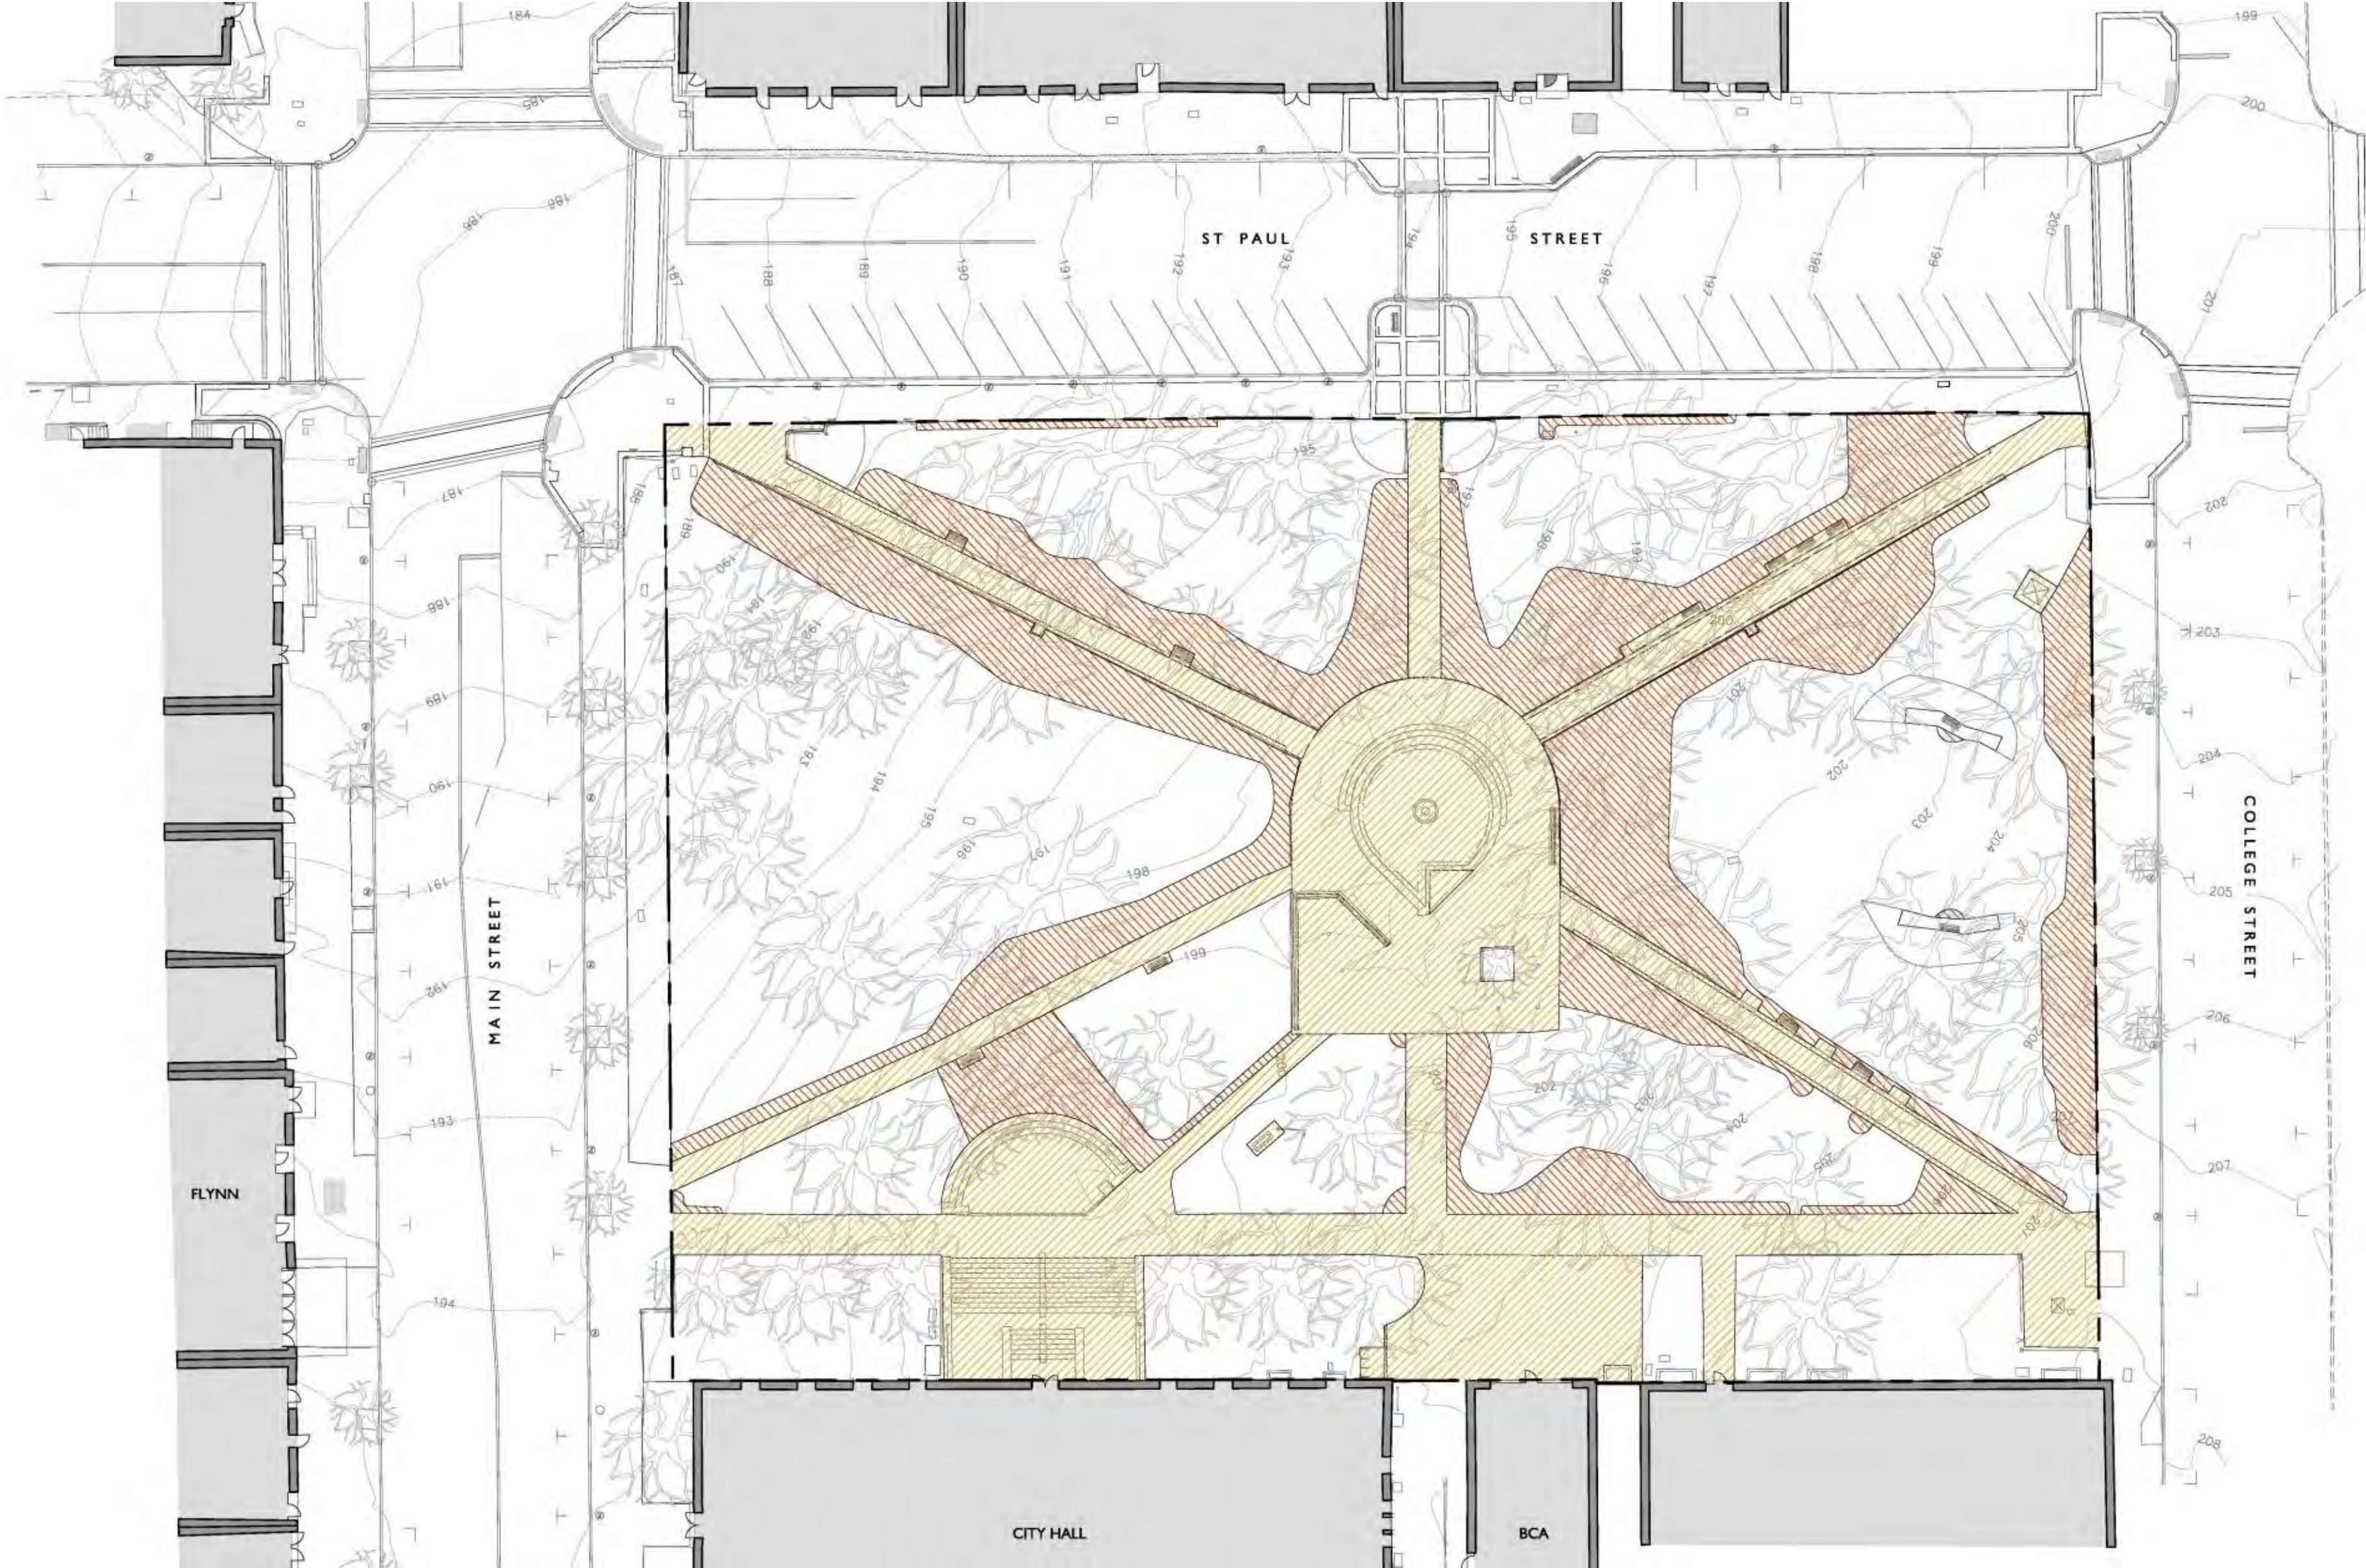
Compaction – Existing Lot Coverage

2016 Site Analysis

Impervious = 33,905 sf (43.8%)

Hardscape  
19,750 sf (25.2%)

Compacted Soils  
14,565 sf (18.6%)

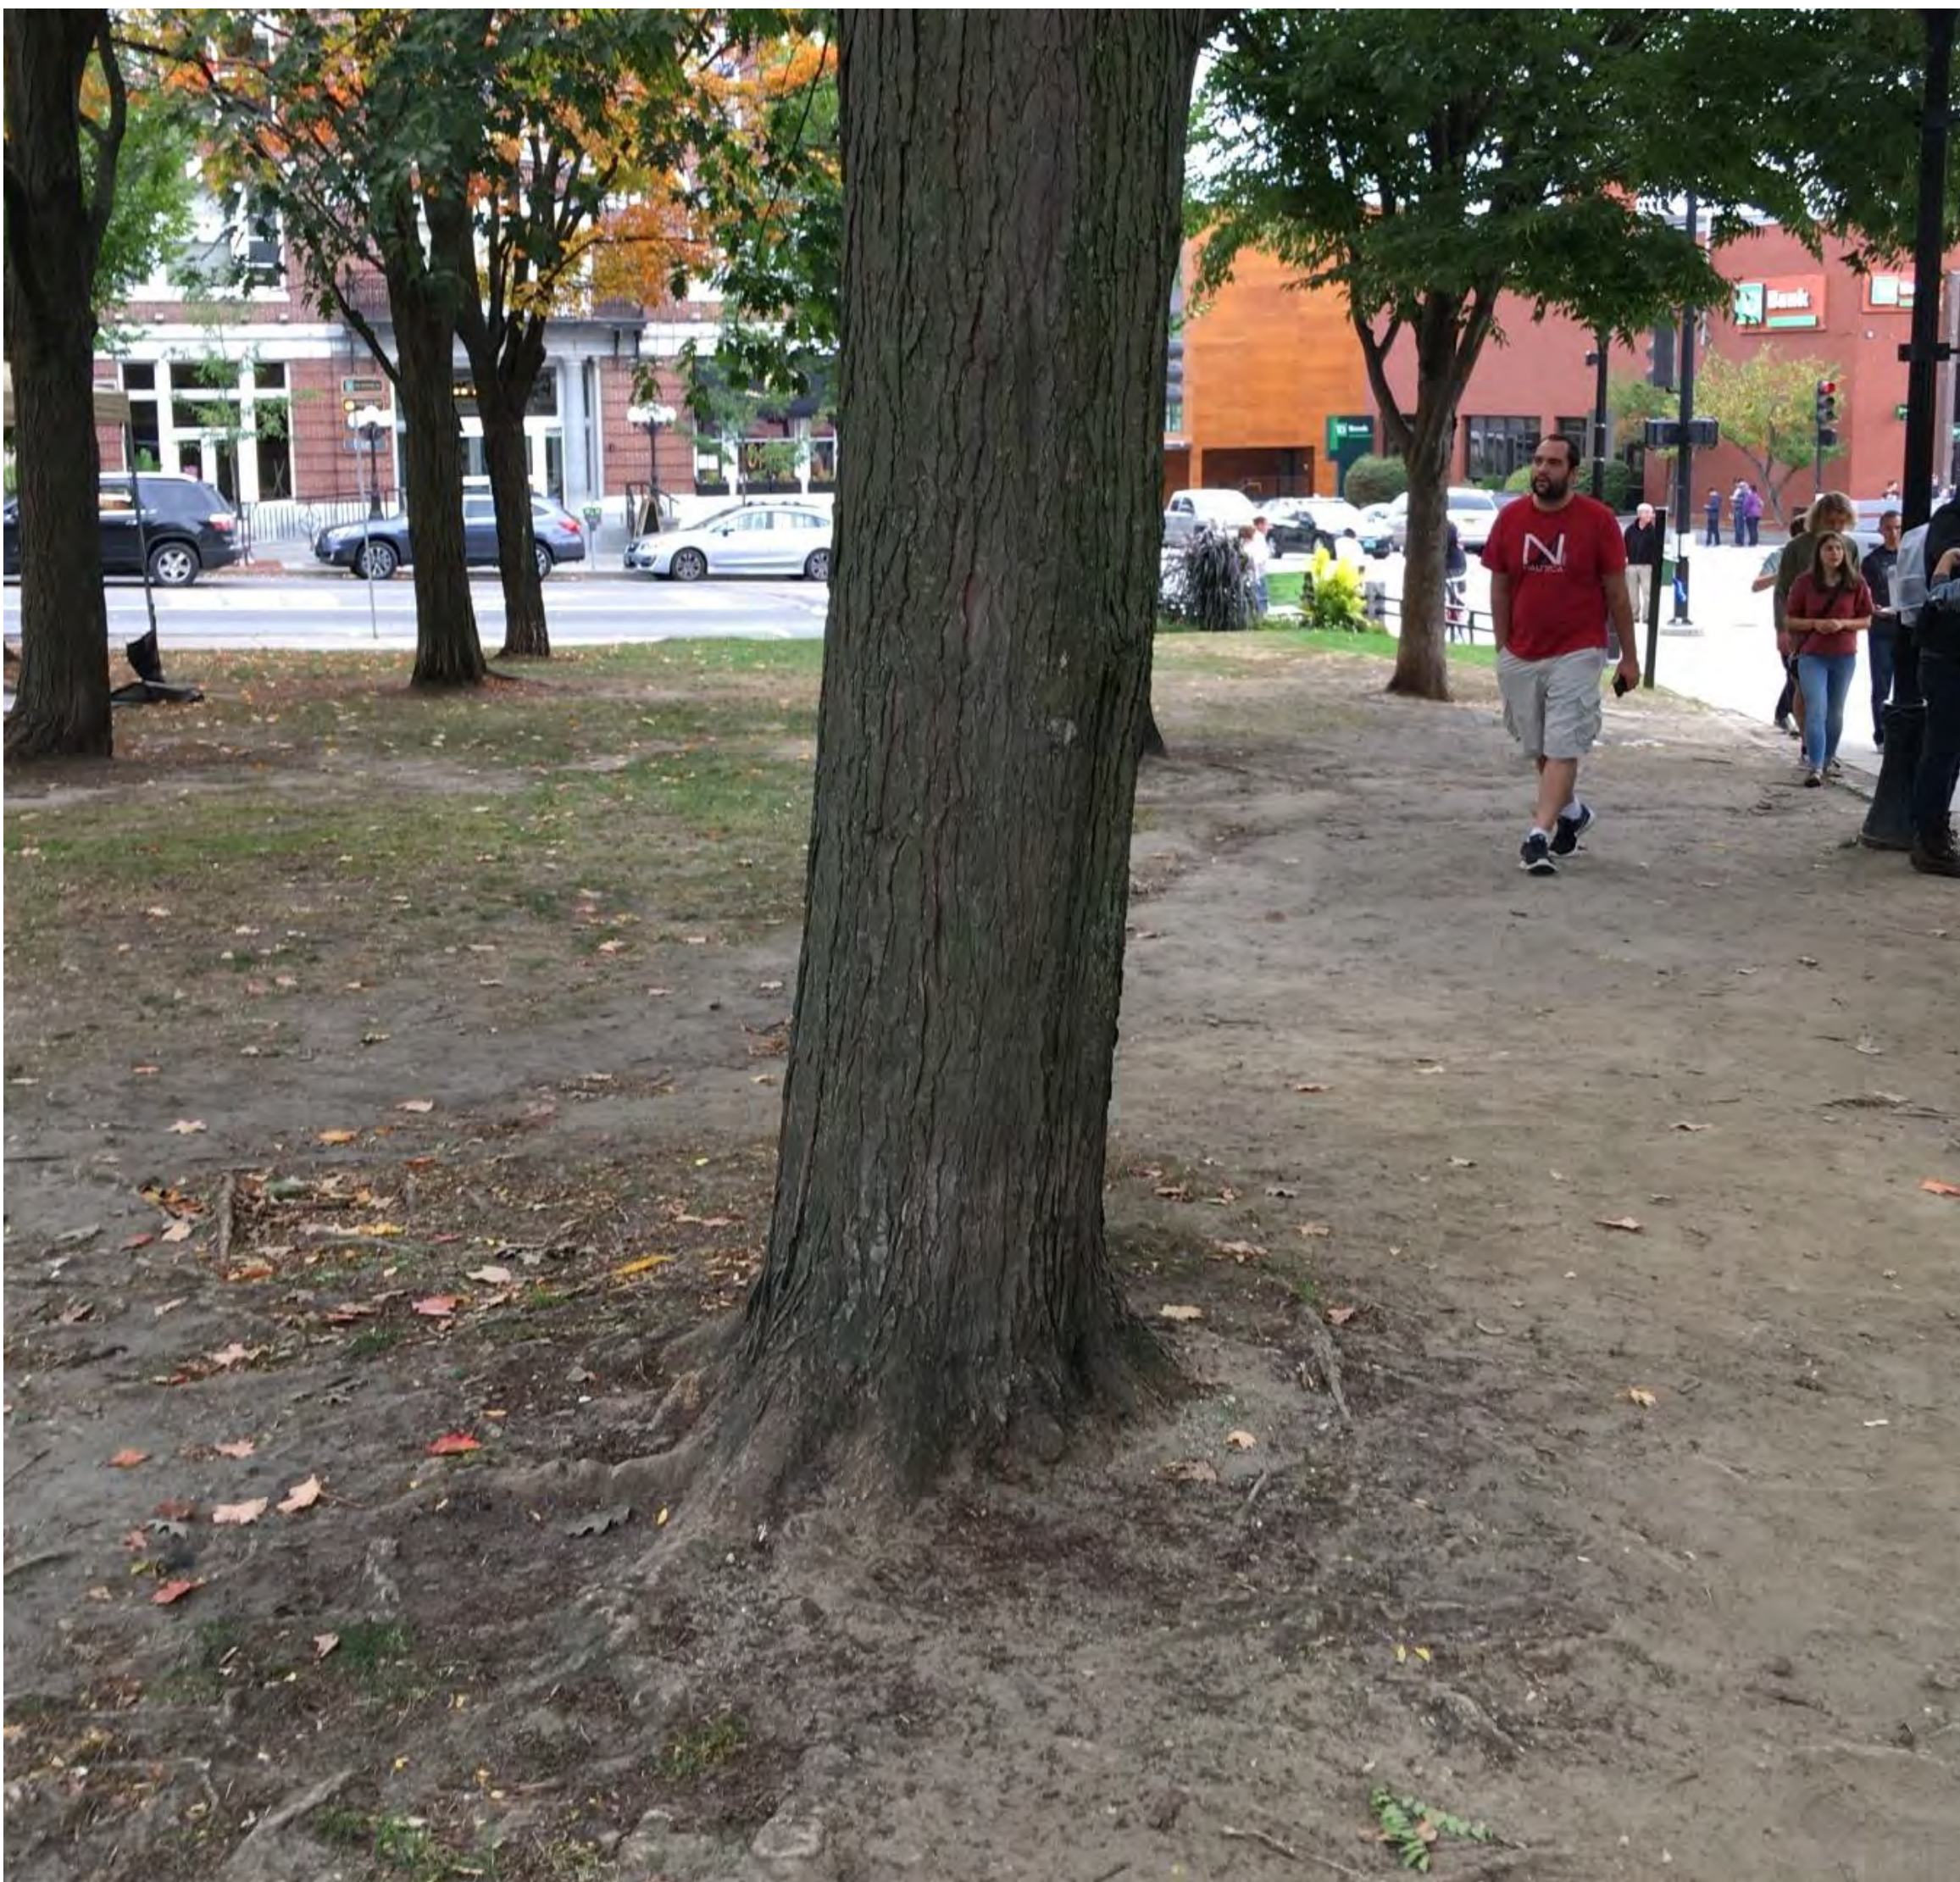
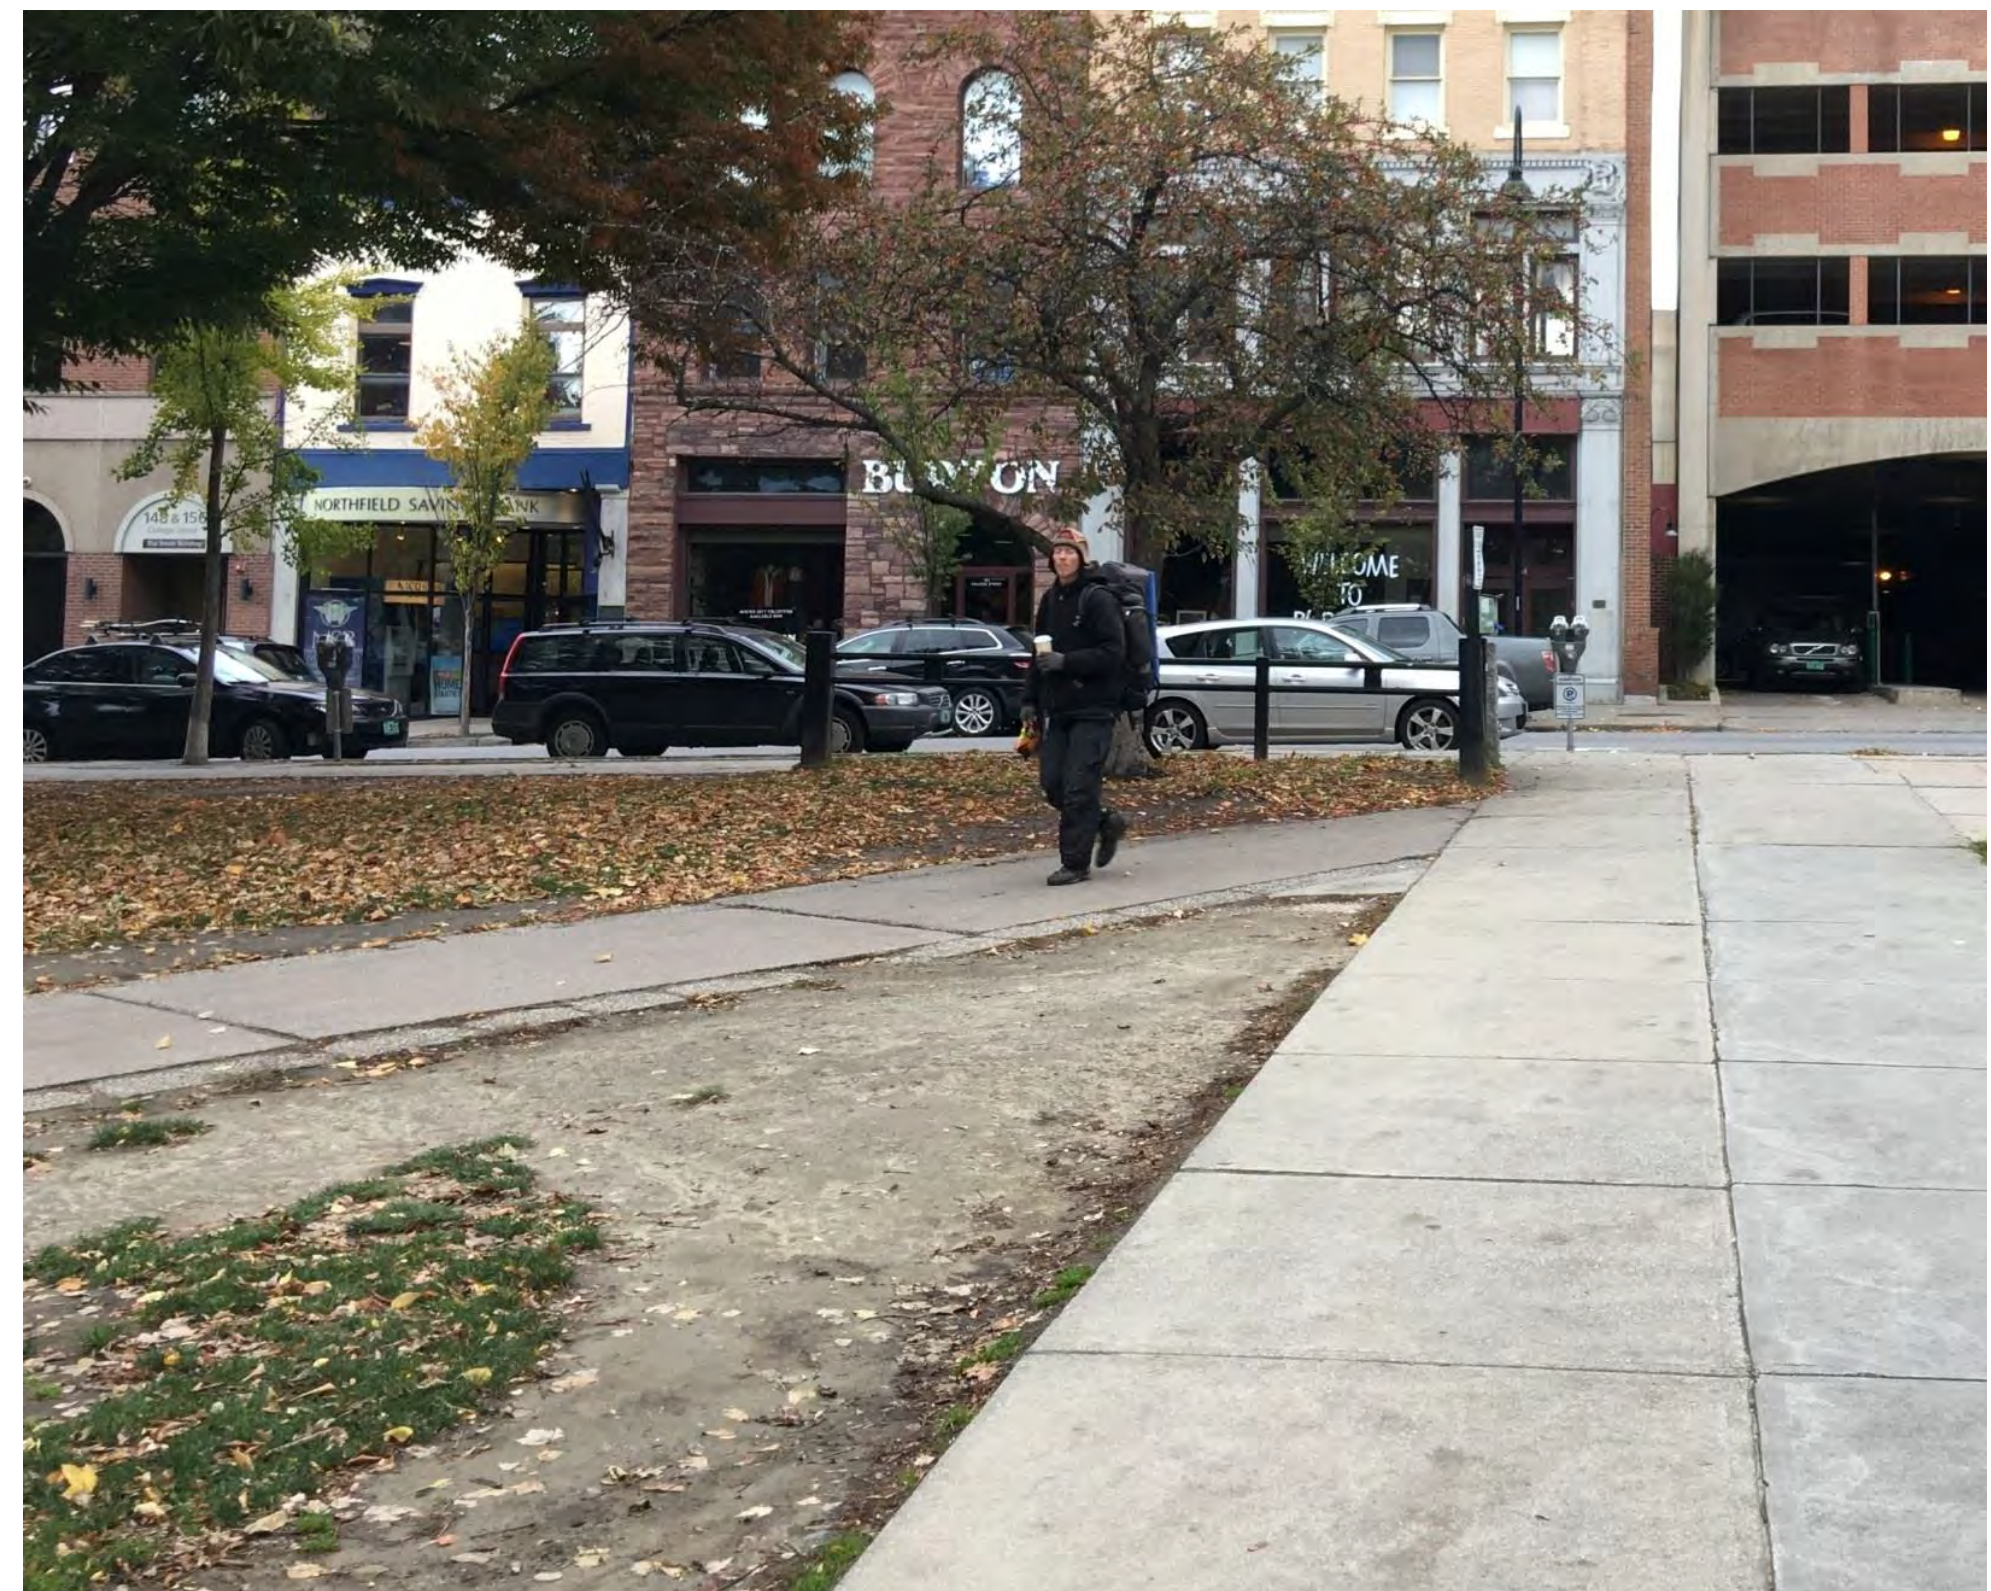
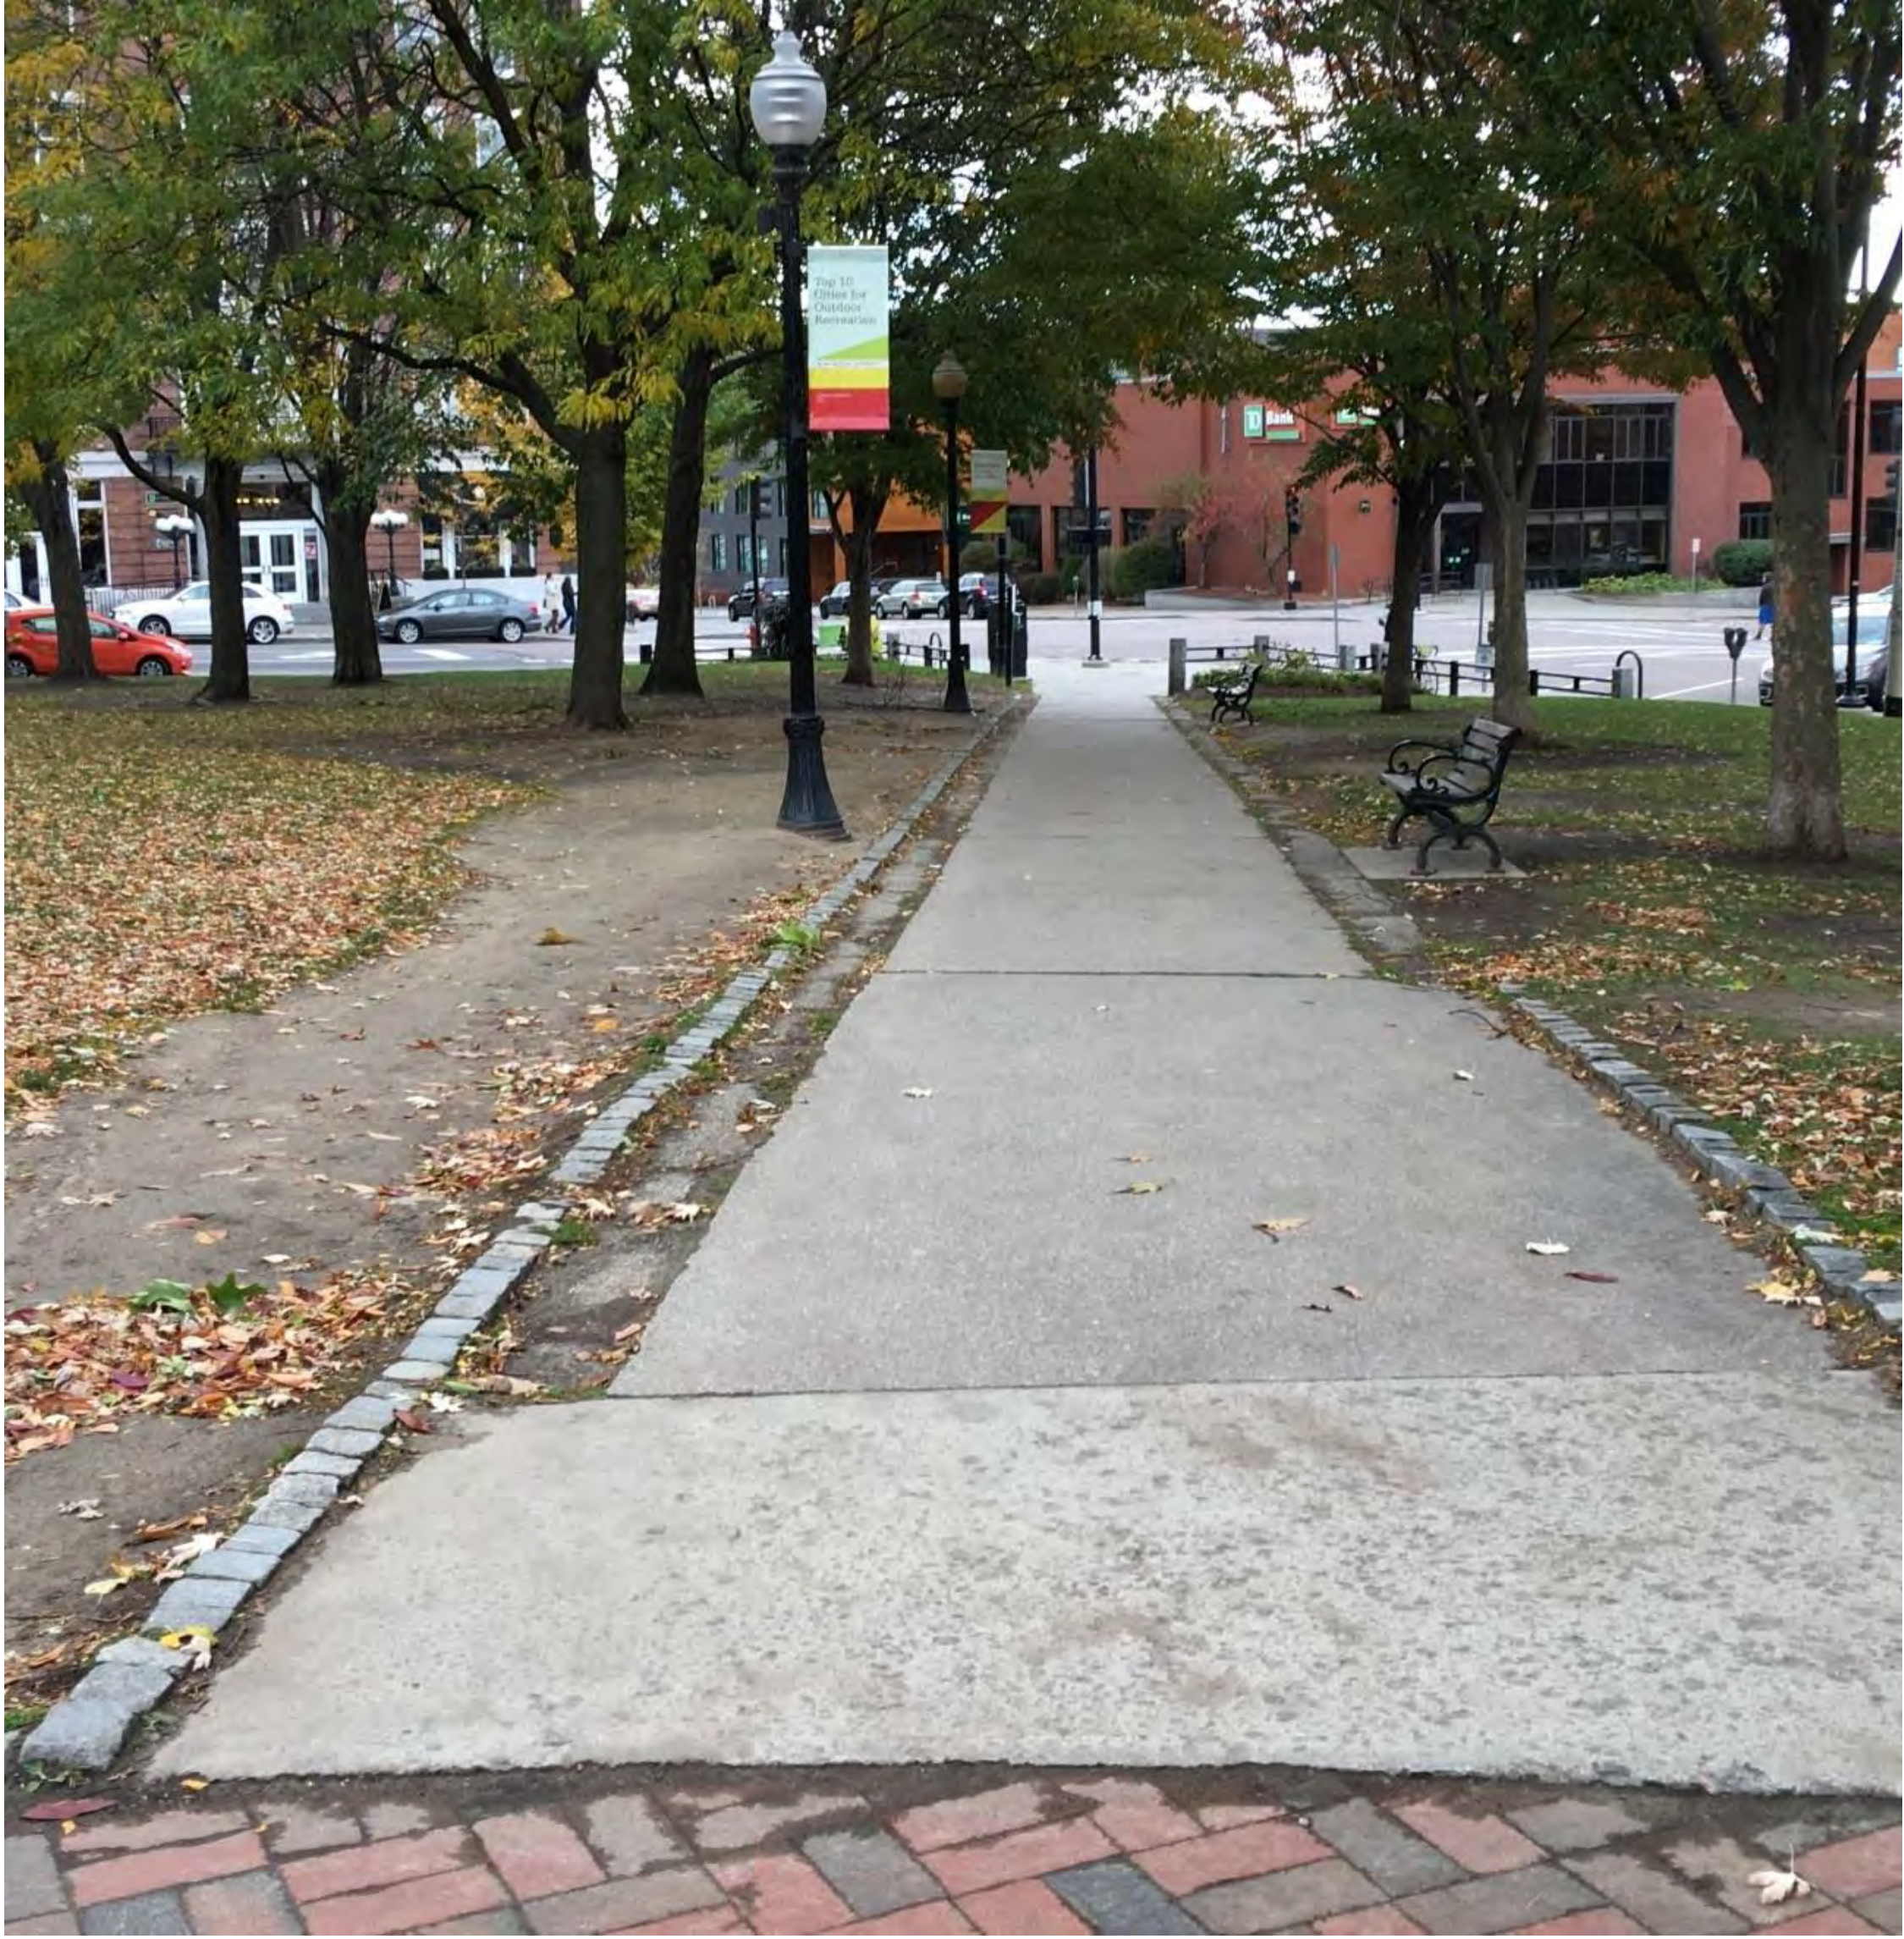
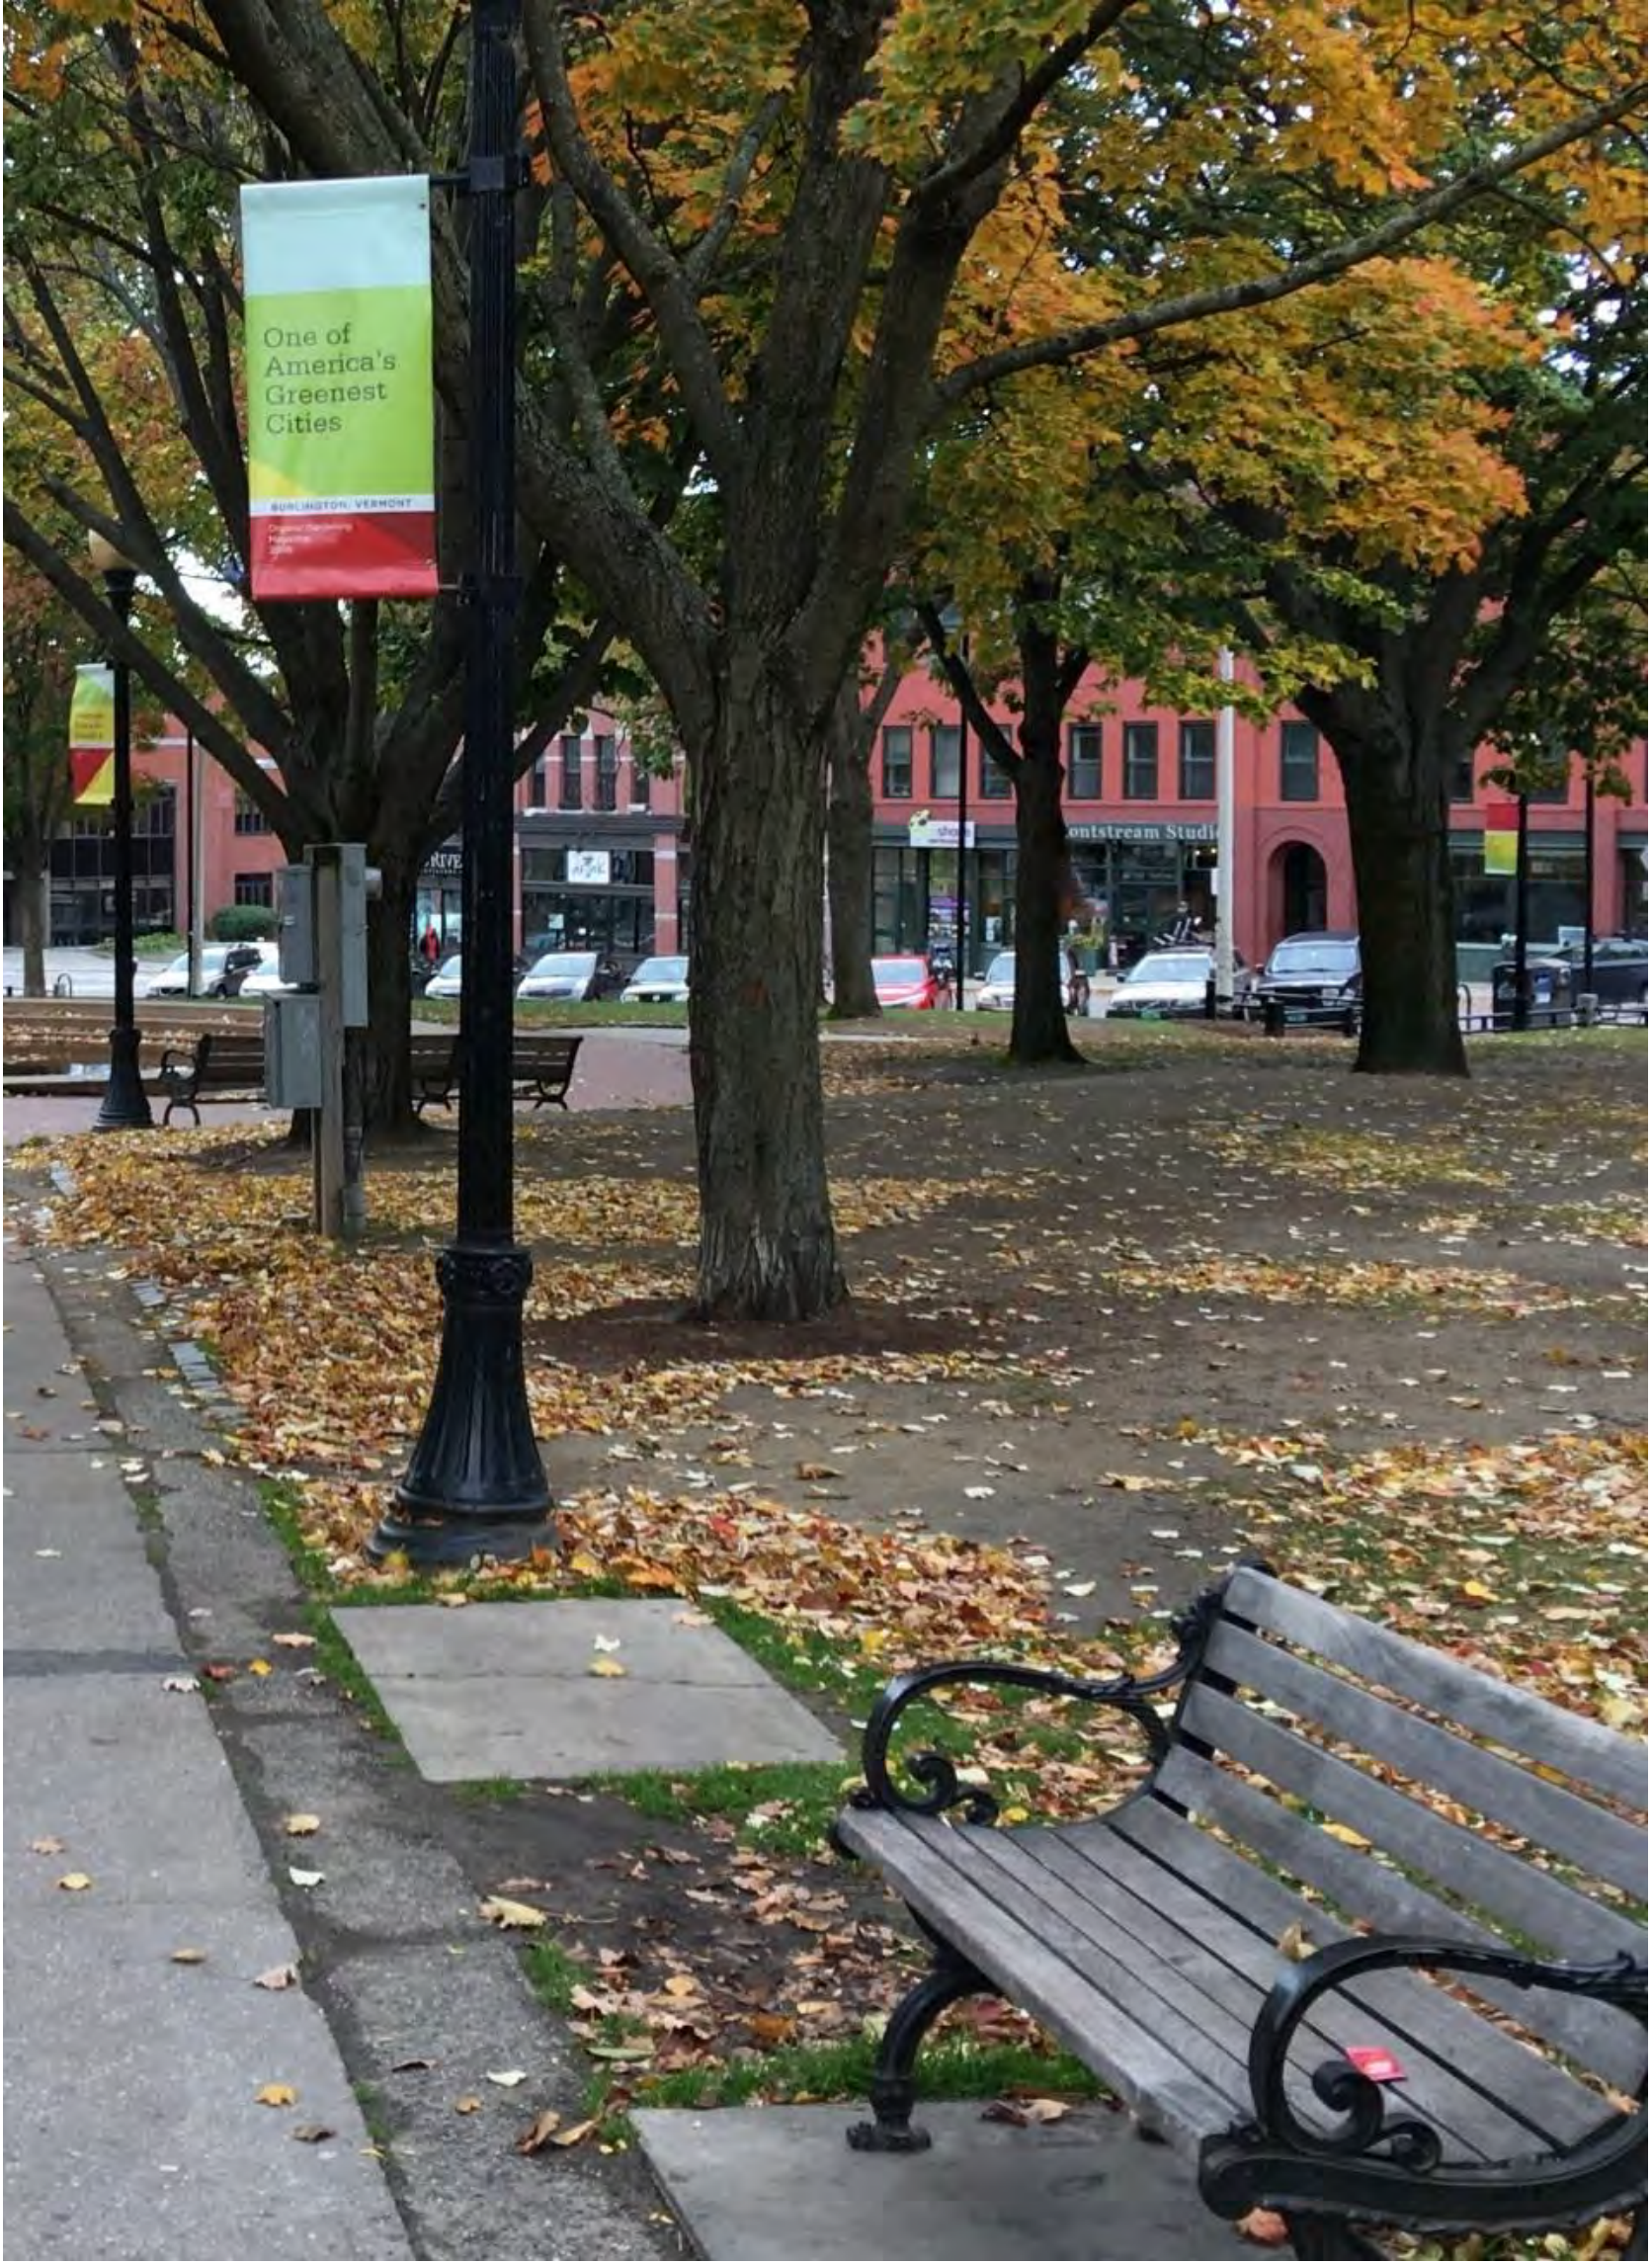
Loss of turf grass due to foot traffic, compaction & heavy tree canopy / surface roots.
